CR-134123

REFURBISHMENT OF SOLAR SIMULATOR  
OPTICAL TRAIN MIRROR ASSEMBLIES

EOS Report 1155 - Final  
September 1973

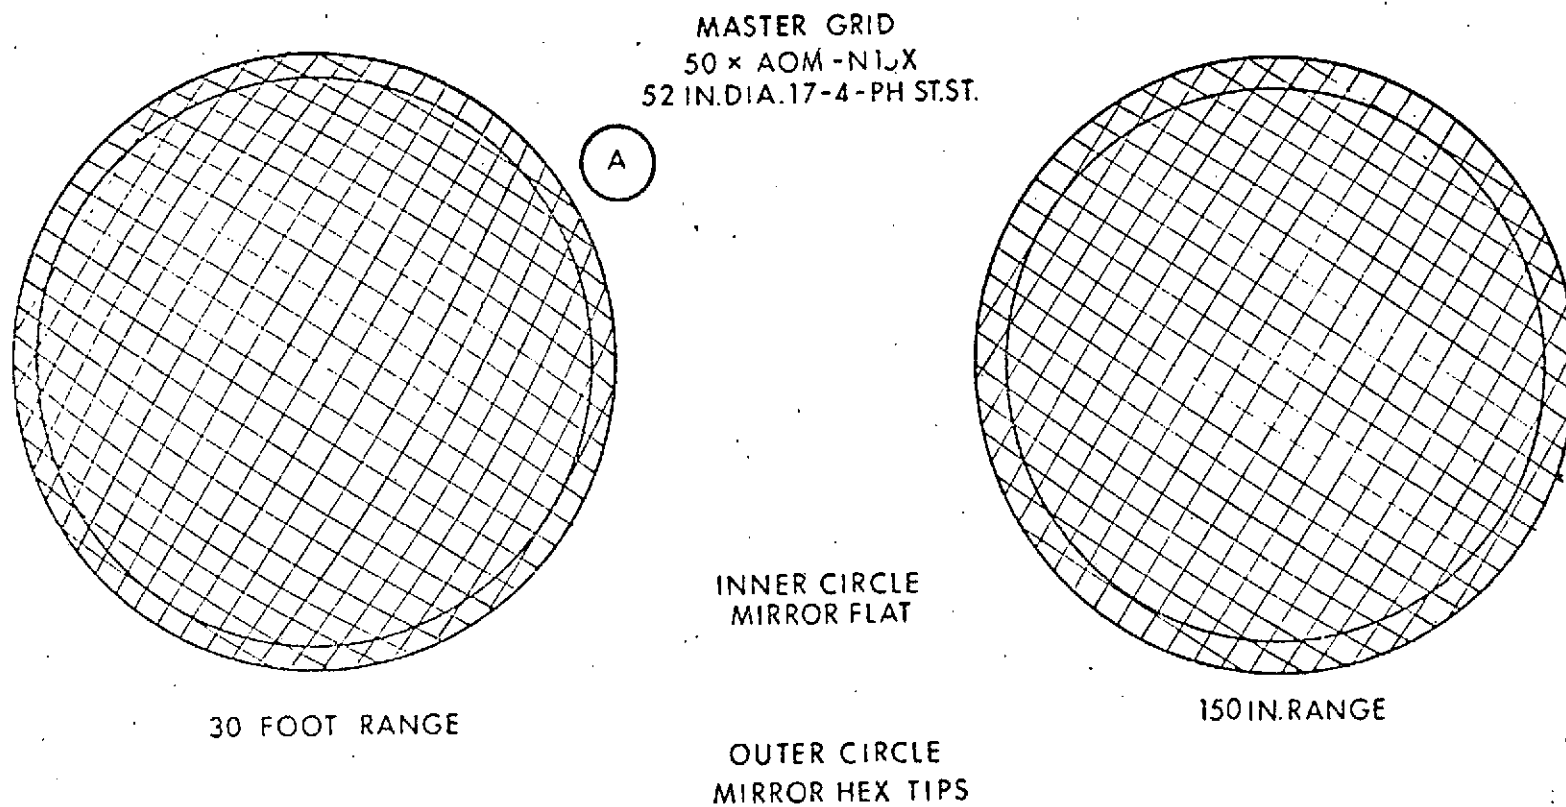
Figure 5 No. 4 Grid Photo

made using the 150-in. range; but, in addition, the 2-in. square grid is projected on the target screen. The grid is made from 1/4-in. strips of steel spaced on 2-in. centers and mounted in a frame. Photos were made of the pattern produced by this grid at 150 and 360 in. using the stainless steel master. The photo was used to compare the projection of the mirror under test and the grid produced by the master at both ranges (Fig. 4). Although it is not required by the test procedure, all No. 4 Mirrors are now checked with the test mask projection every 2 in. around the diameter, as shown in Fig. 5.
